AN OLD FOUNDATION

WITH NEW INTENTIONS

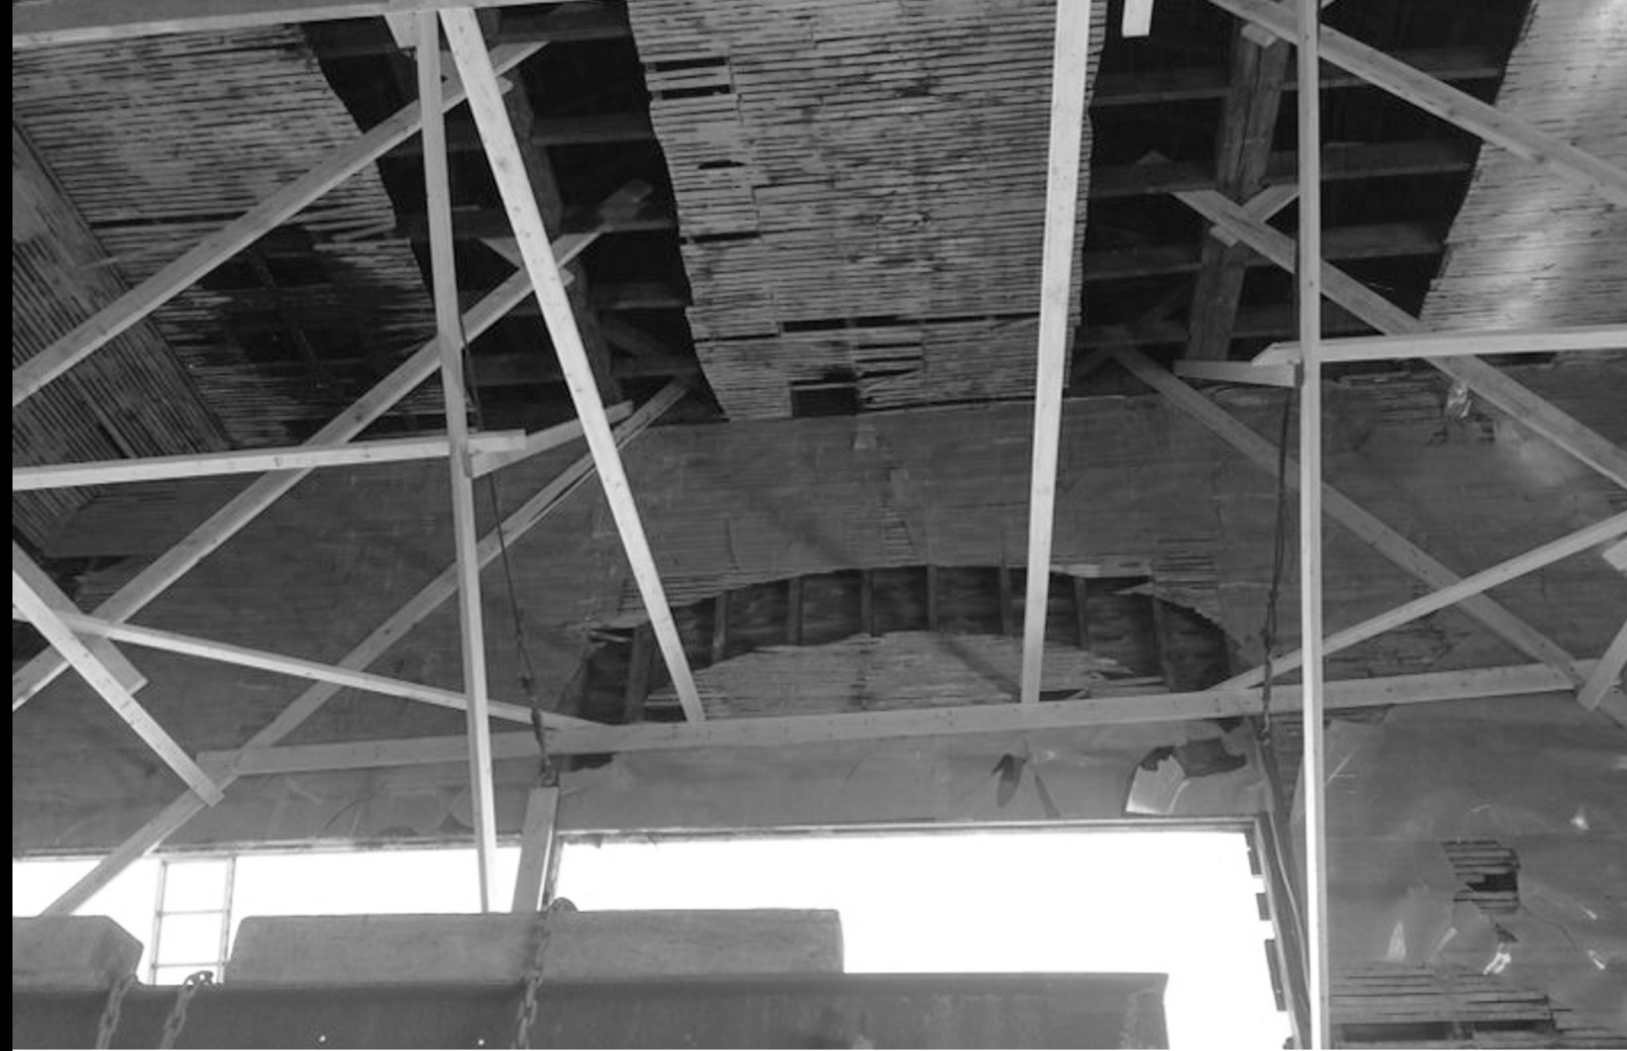
- WOOD TIMBER FRAME IN SOUND CONDITION
- PLASTER HAD DEGRADED FROM YEARS OF NEGLECT
- ORIGINAL LATH REQUIRED REPAIR
- ORIGINAL BARREL VAULTS AT SIDE WALLS HAD MINIMAL DAMAGE
- ORIGINAL MEZZANINE FLOOR WAS SLOPED FOR GALLERY SEATING
